## Repairing refrigerant circuit

## Removing and installing air conditioner high-pressure sender -G65

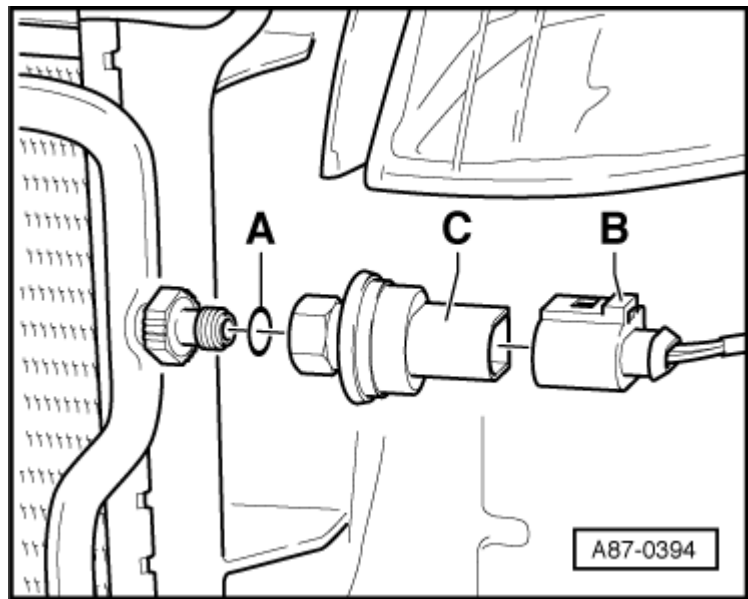
- – → Detach connector -B-.
- – Remove high-pressure sender -G65 -C-  
Tightening torque: 5 Nm.
- – Replace O-ring seal -A- (10.8 mm; 1.8 mm) =>Page [87-27](#).

- ♦ The illustration shows the high-pressure sender -G65 on a condenser for vehicles with a 2.0l or 3.0l petrol engine, with other condensers the high-pressure sender is attached on the right -G65 =>Page [87-23](#).
- ♦ The refrigeration capacity cannot be checked if sender -G65 is removed. The operating and display unit -E87 does not switch on the compressor.
- ♦ The refrigerant circuit remains closed - connection with valve.
- ♦ Checking function of high-pressure sender -G65 and the signal emitted =>Page [01-348](#).
